NAVAL FACILITIES ENGINEERING SERVICE CENTER
Port Hueneme, California 93043-4370

Technical Report TR-2067-ENV

SURFACE QUALITY IMPACT OF REPLACING VAPOR DEGREASERS WITH AQUEOUS IMMERSION SYSTEMS

March 1997

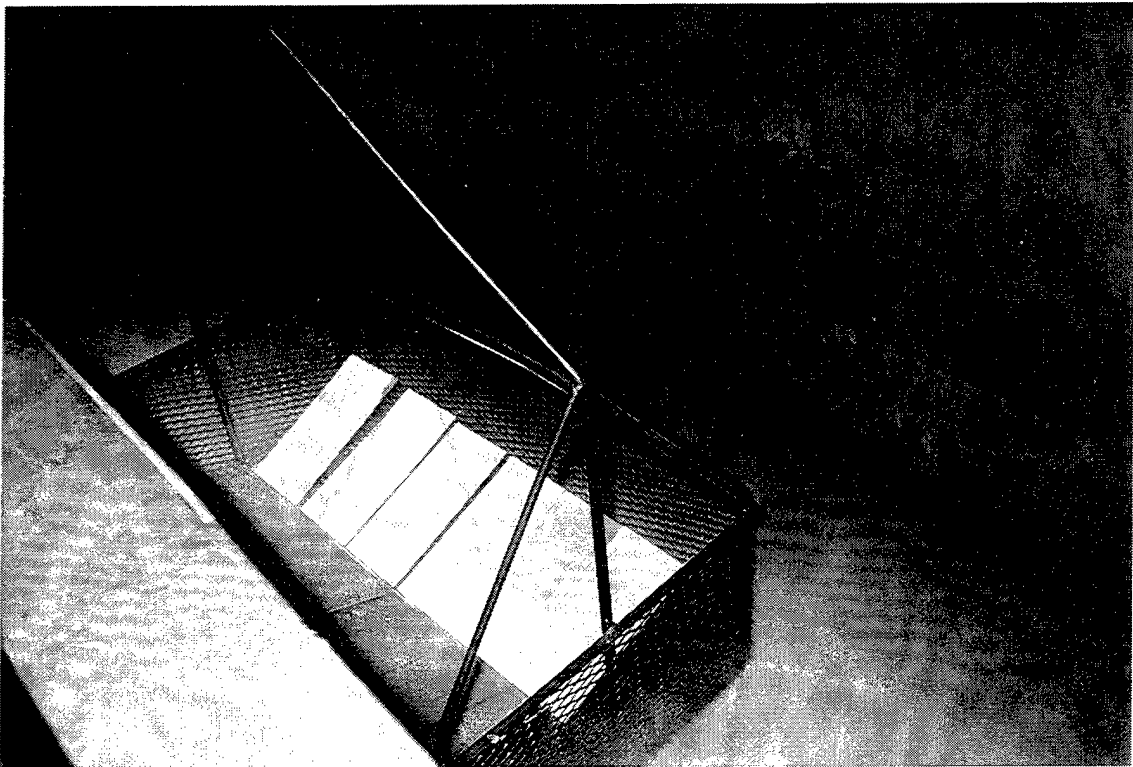
Figure 1. Soiled aluminum panels lowered into TCE vapor degreaser.

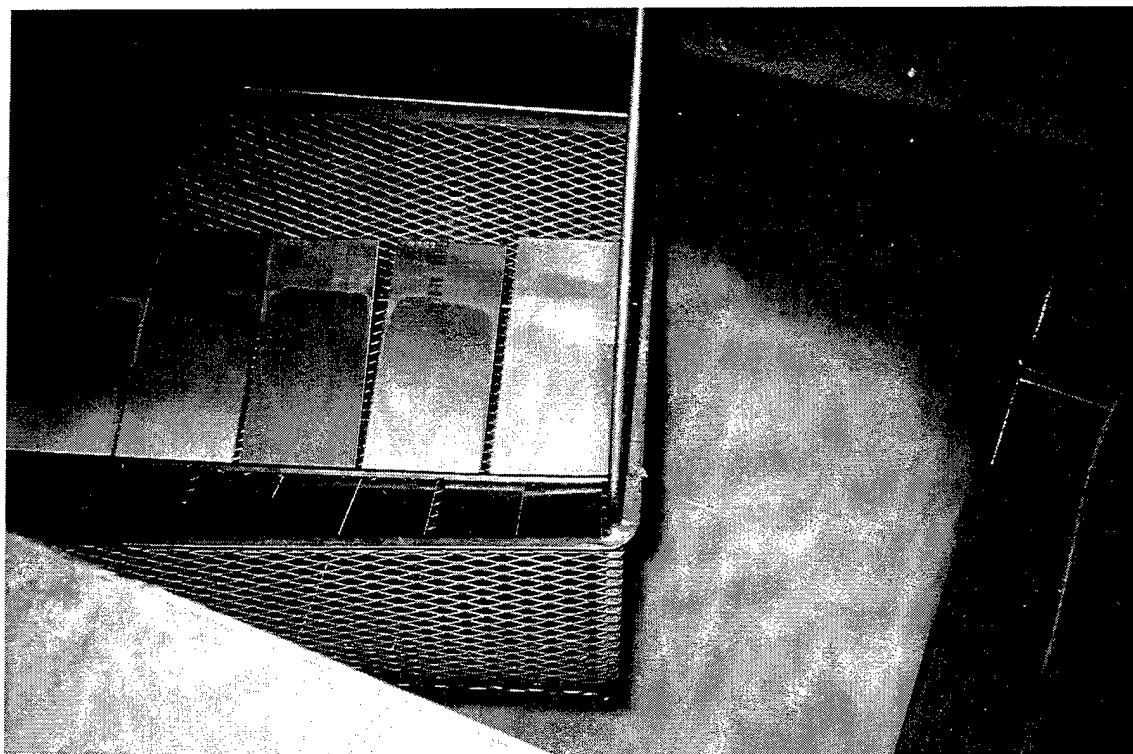
Figure 2. Clean panels dry immediately when removed from vapor atmosphere.

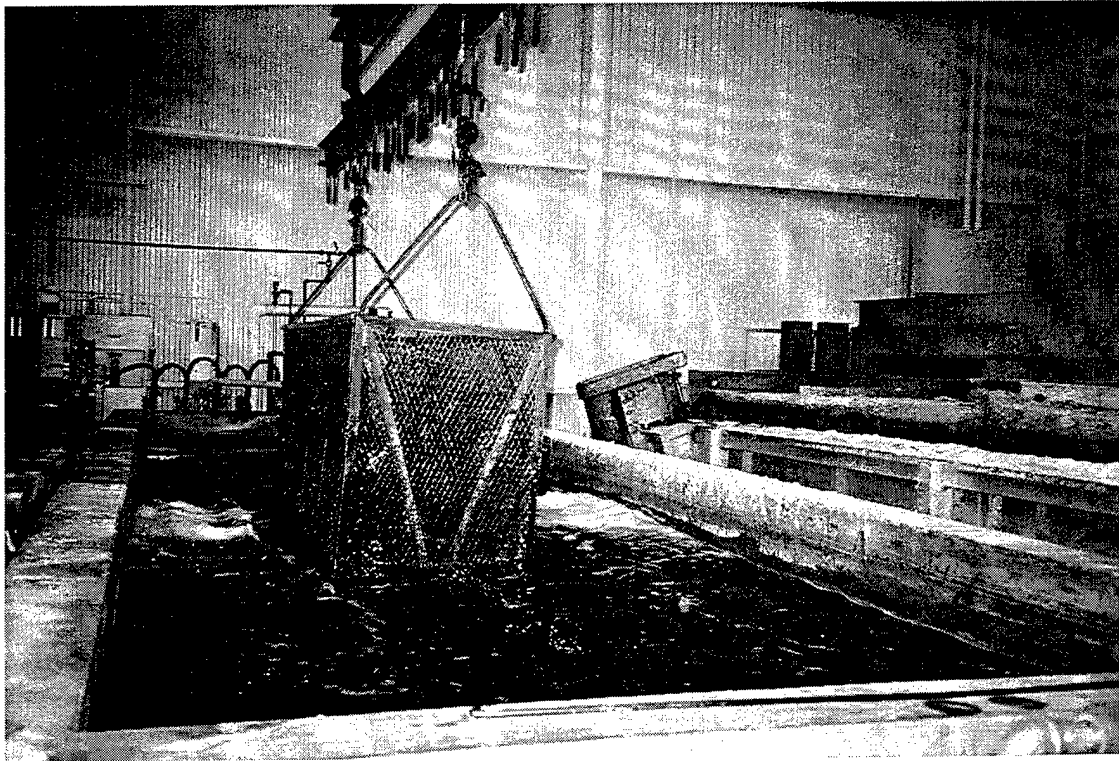
Figure 3. Soiled panels lowered into aqueous immersion cleaner.

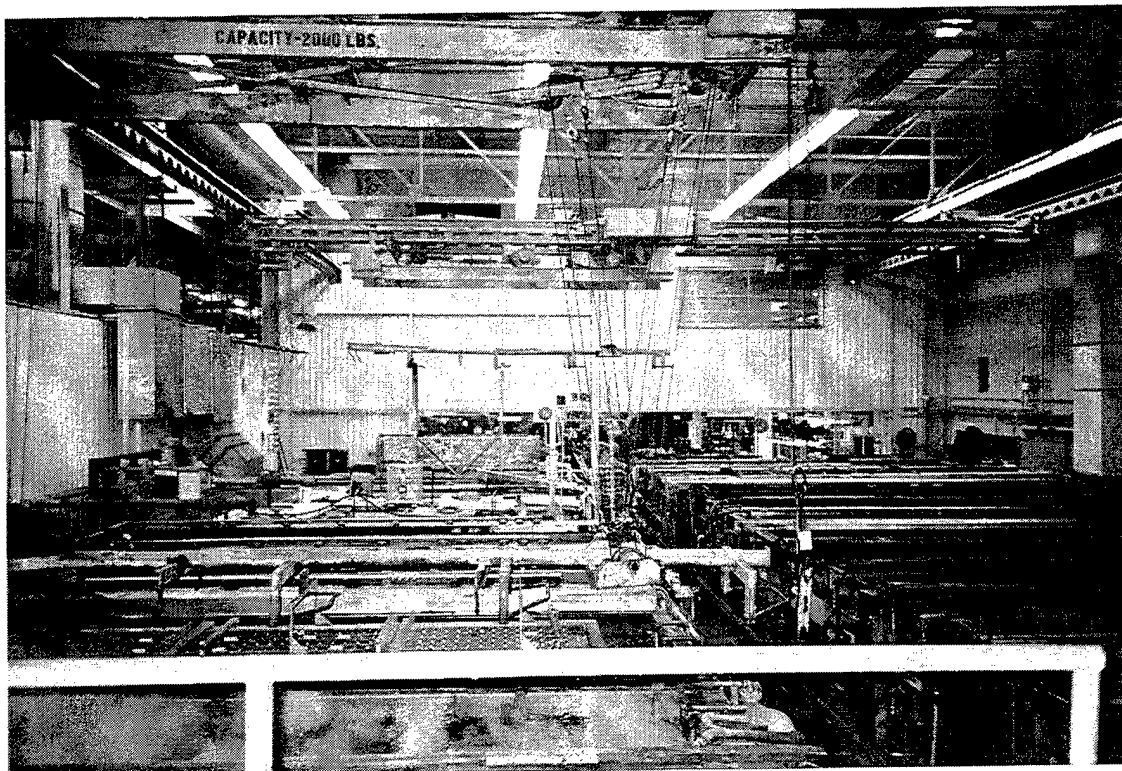
Figure 4. Typical industrial metal finishing tanks.

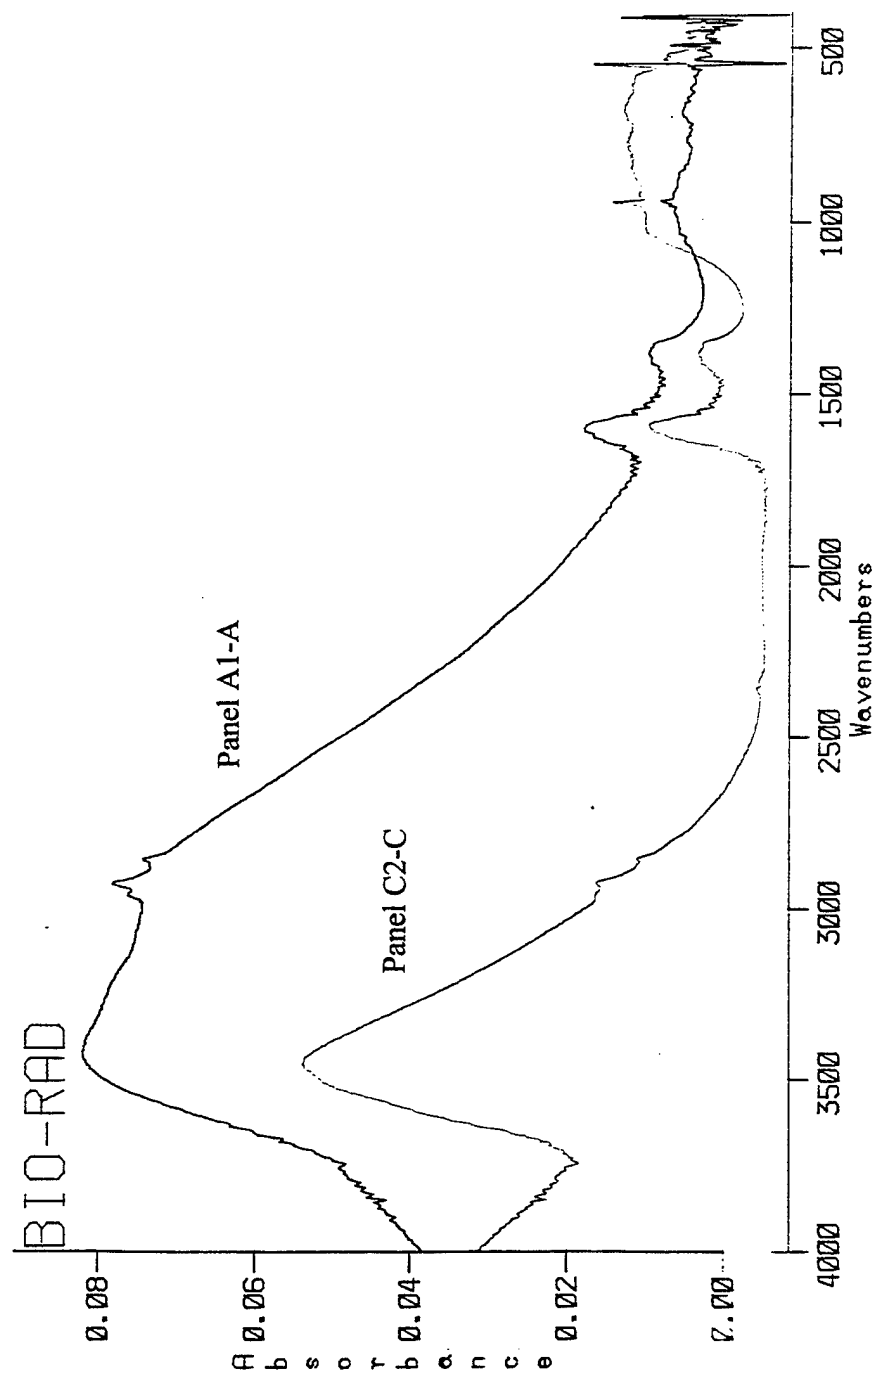
Figure 9. Typical FTIR spectra of panels before Supersoil was applied.

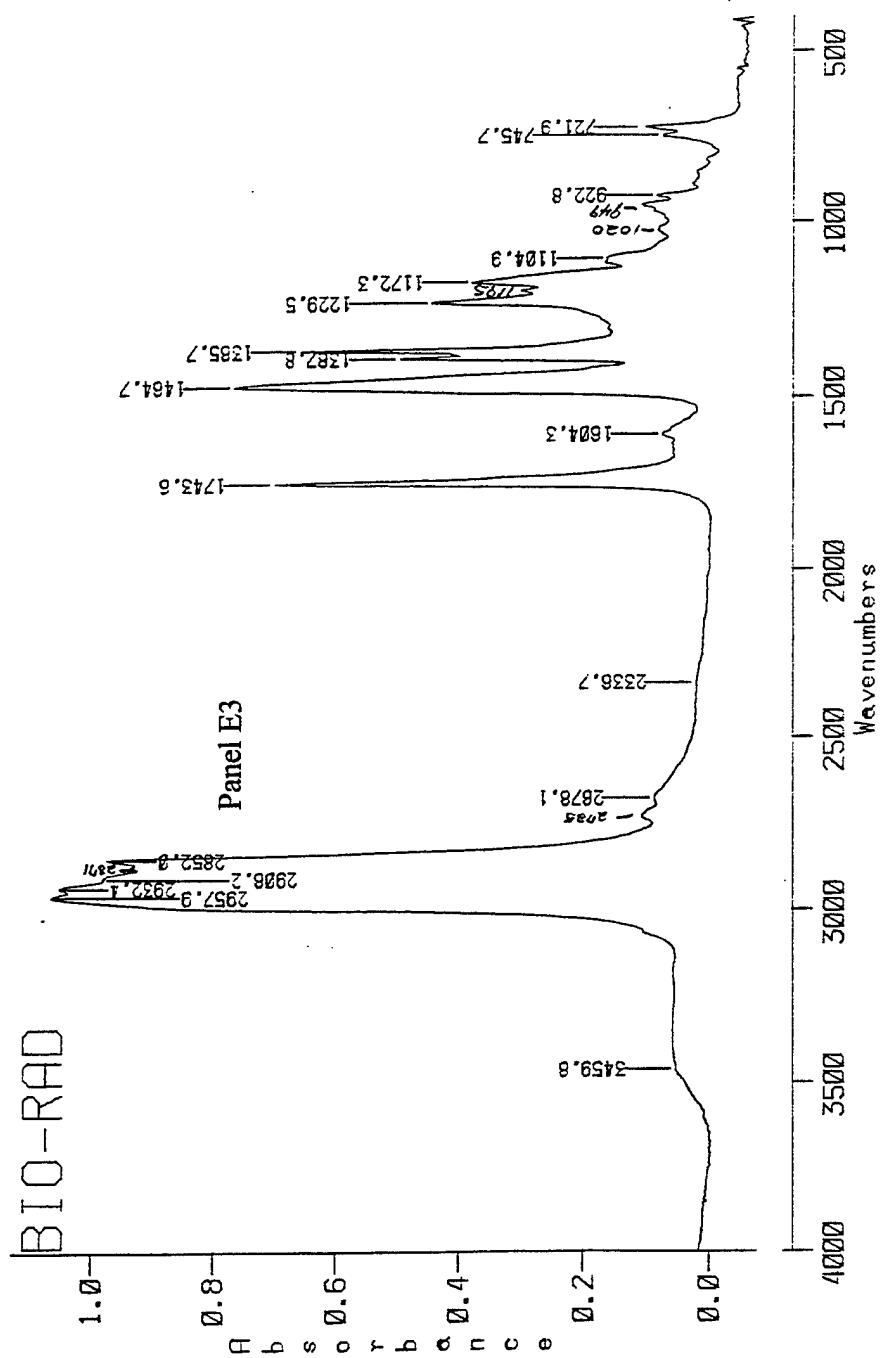
Figure 10. Typical FTIR spectrum of panels after Supersoil was applied.

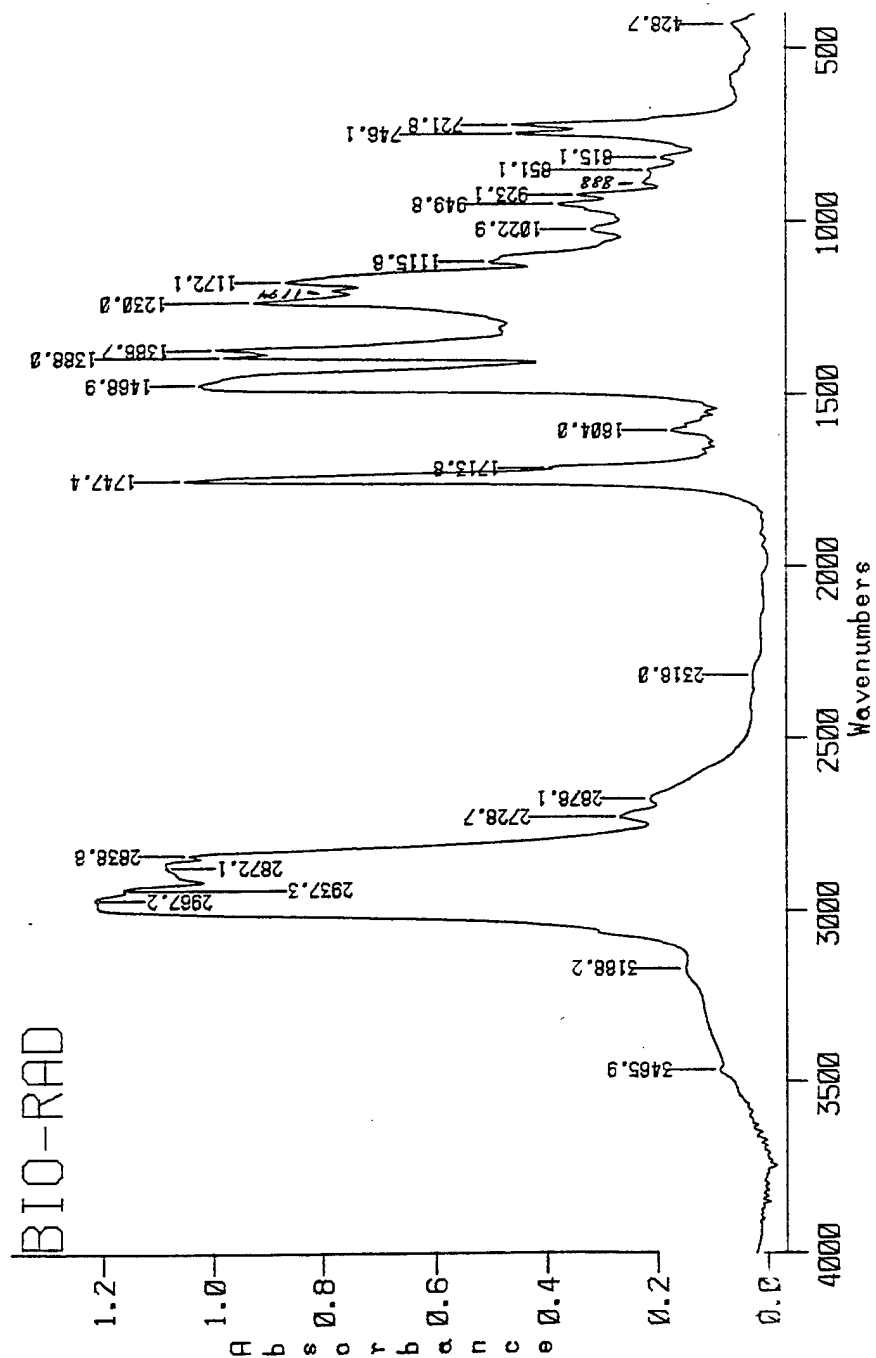
Figure 11. FTIR spectrum of Supersoil.

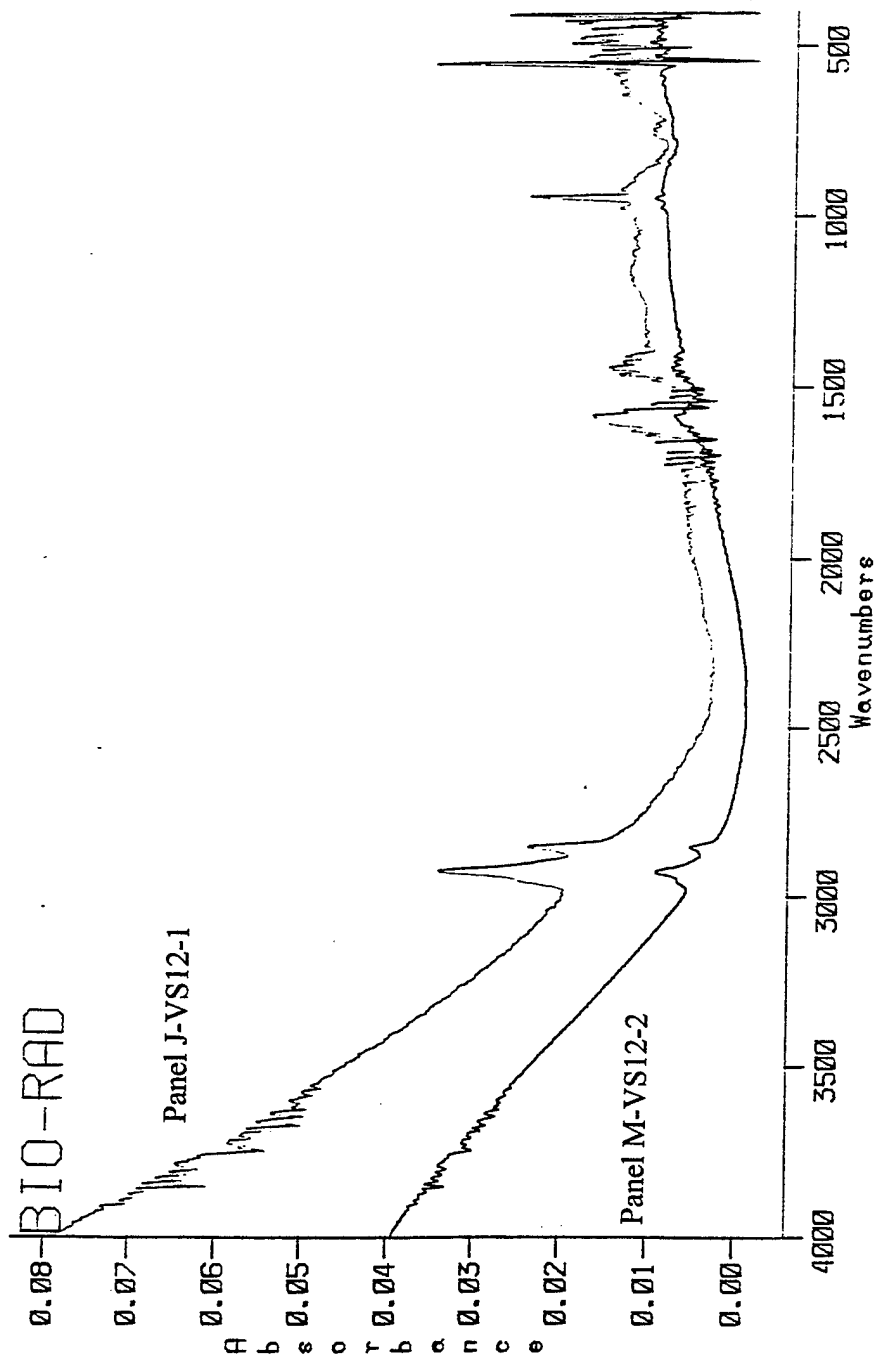
Figure 12. Typical FTIR spectra of soil panels after TCE vapor degreasing.

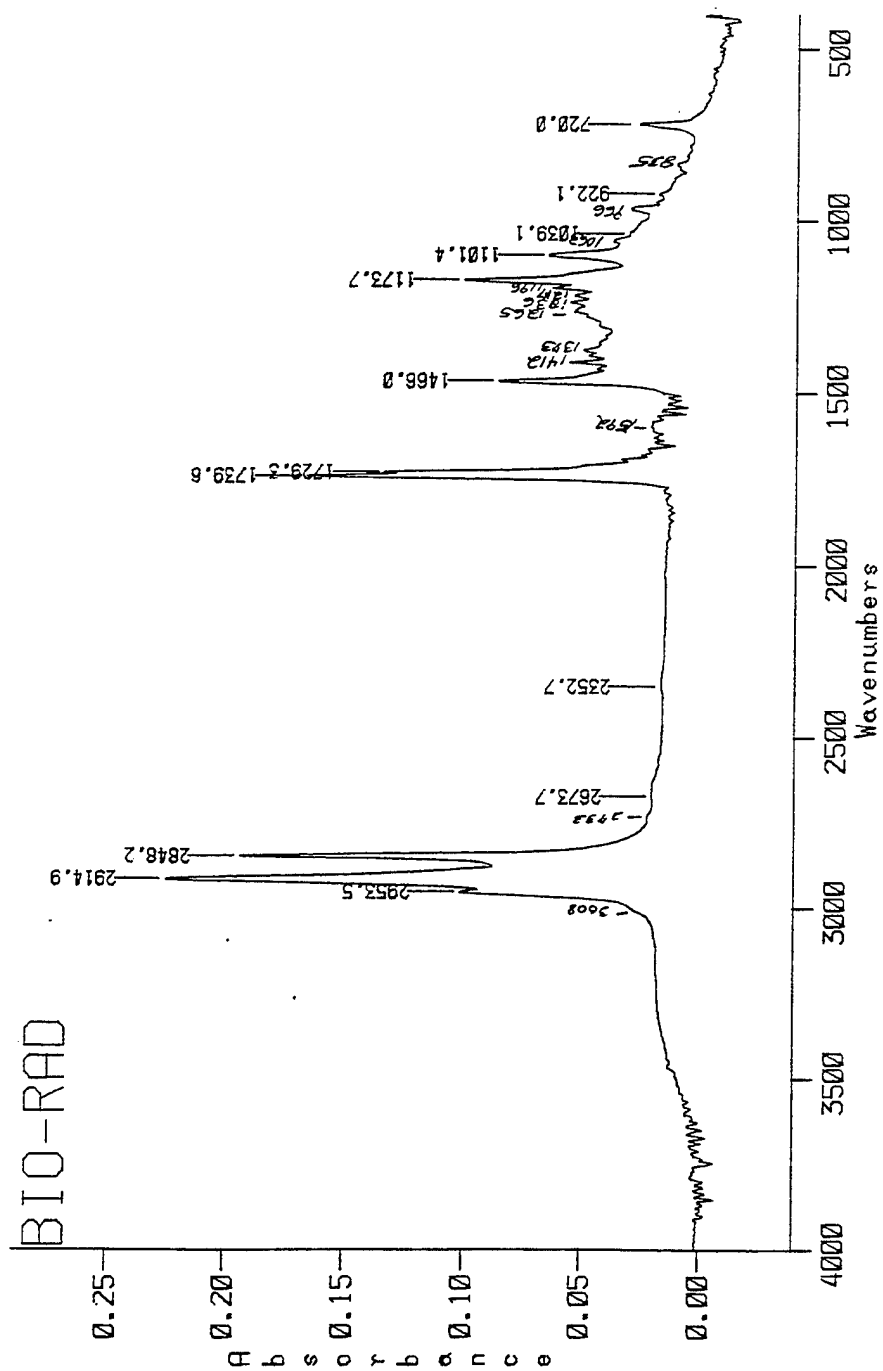
Figure 13. FTIR spectrum of Safety Draw 700.

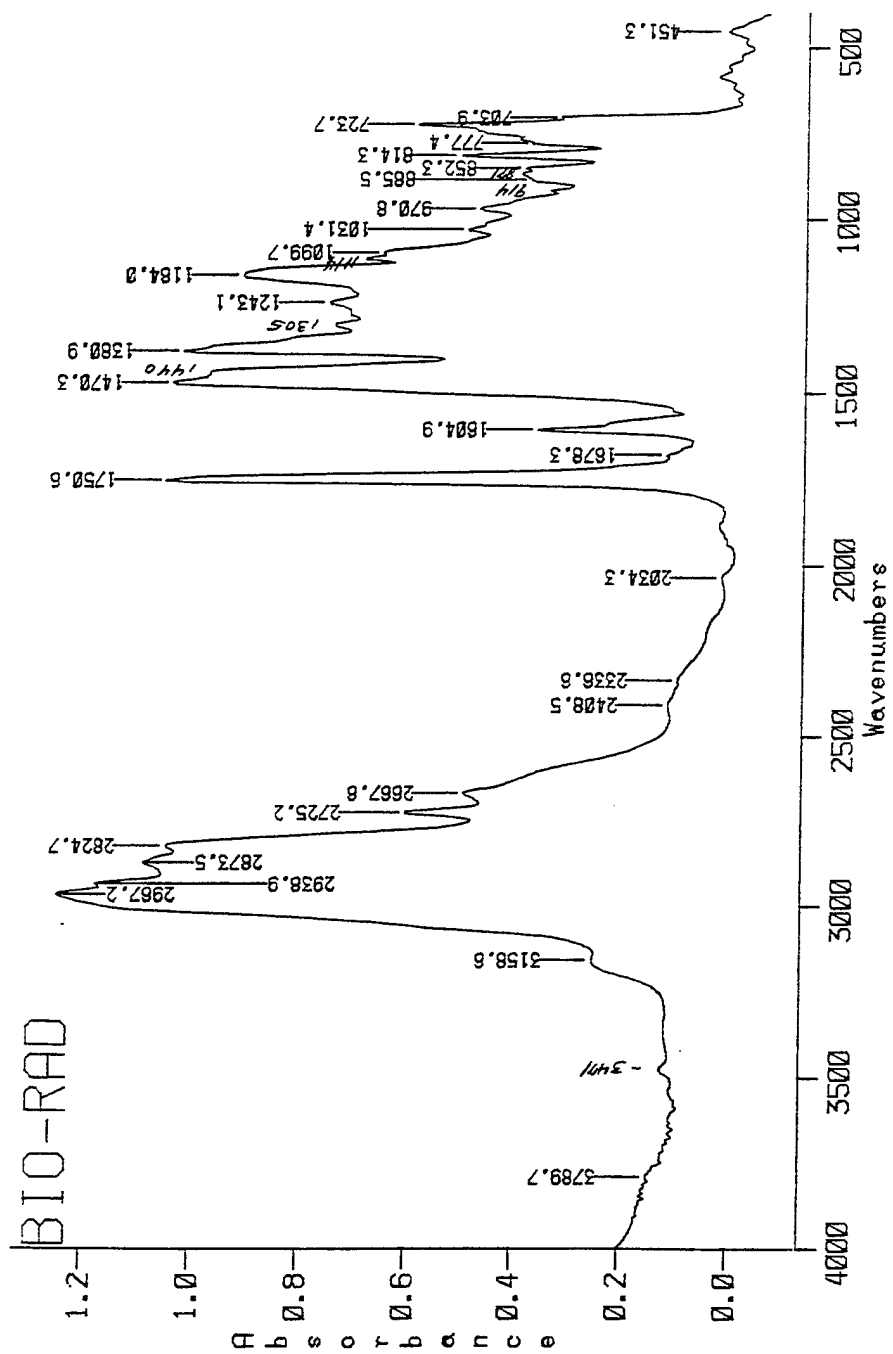
Figure 14. FTIR spectrum of Cimflow #20.

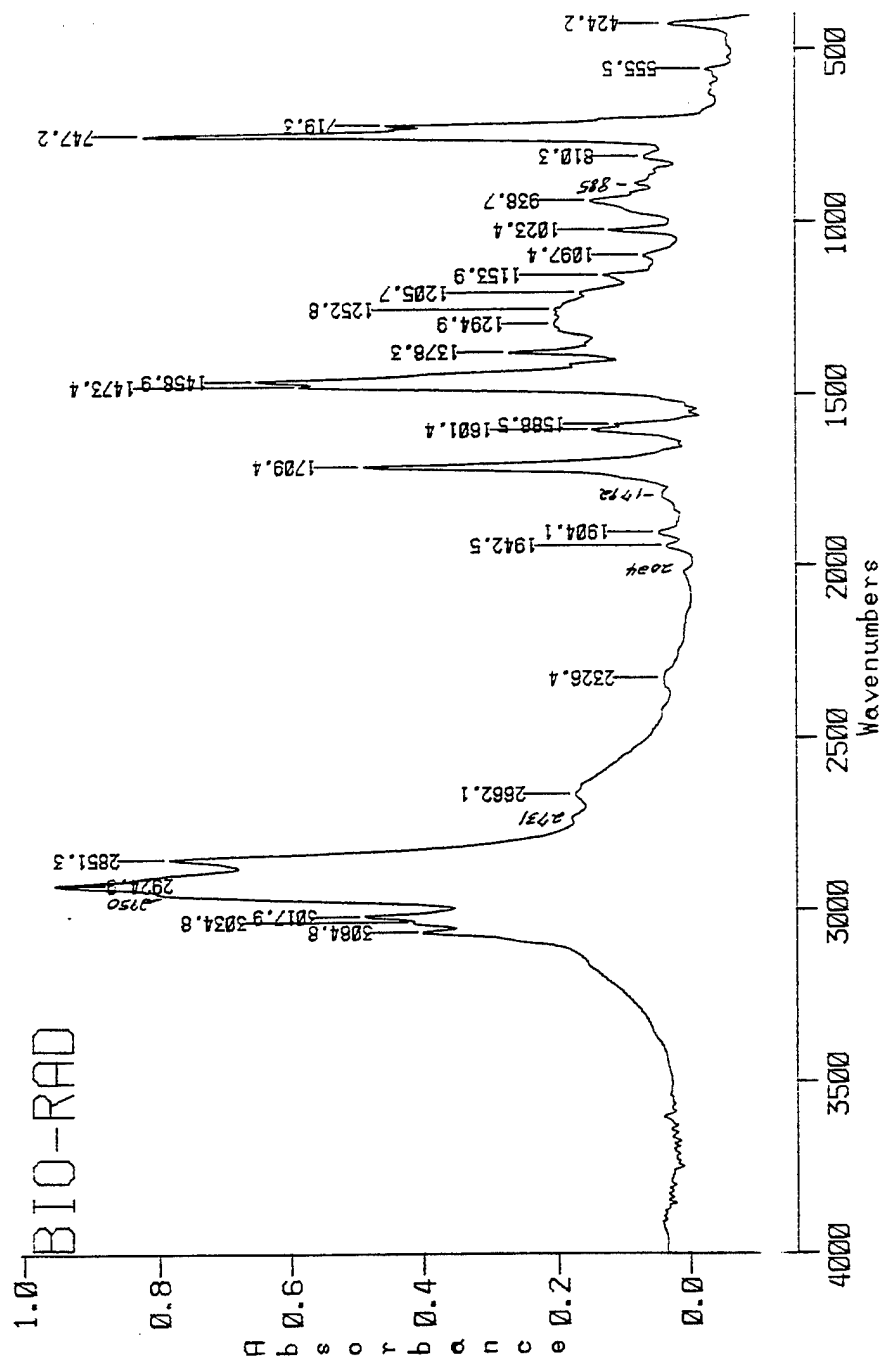
Figure 15. FTIR spectrum of CRC Soft Seal.

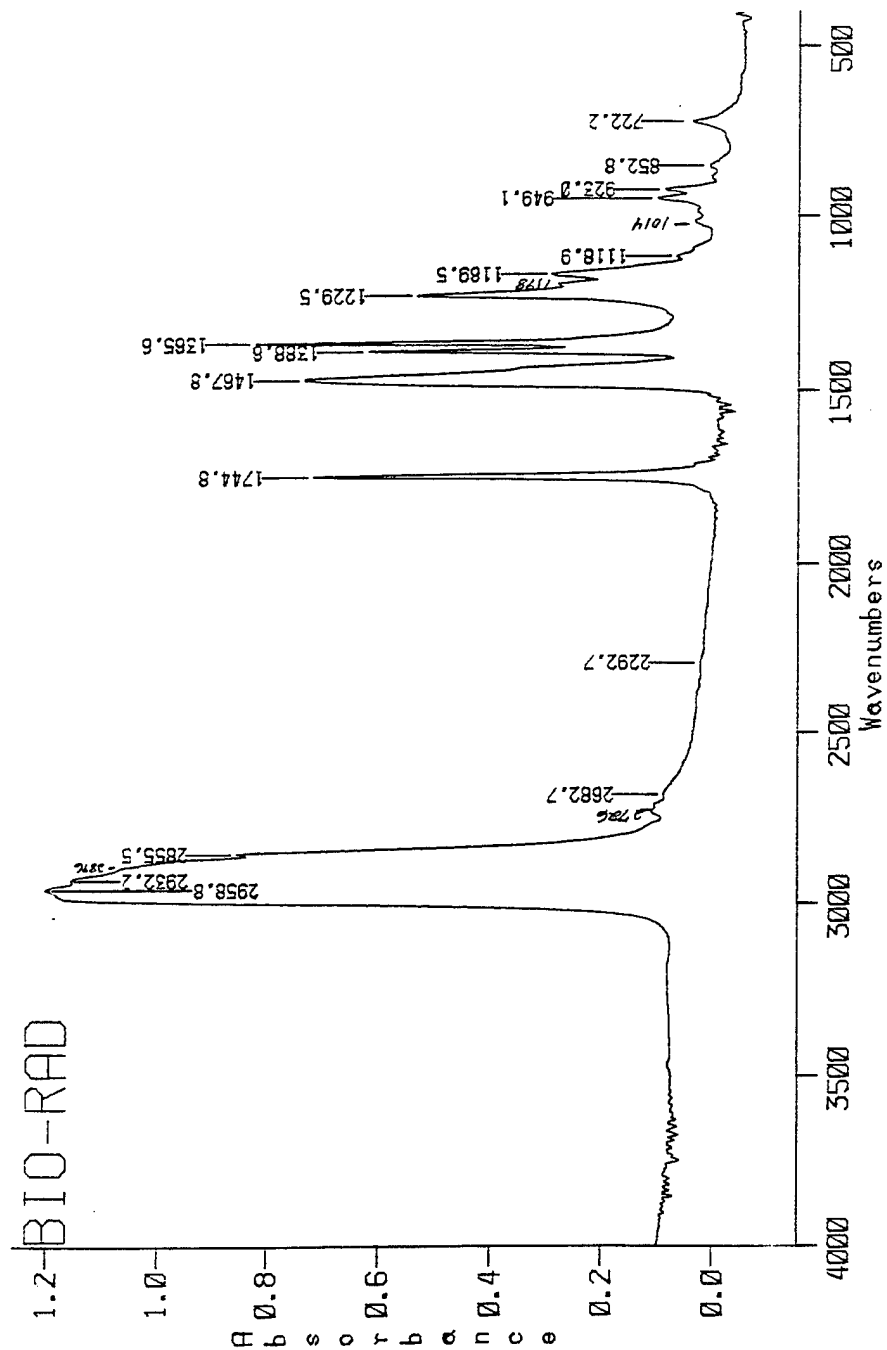
Figure 16. FTIR spectrum of Titan Lube #1129.

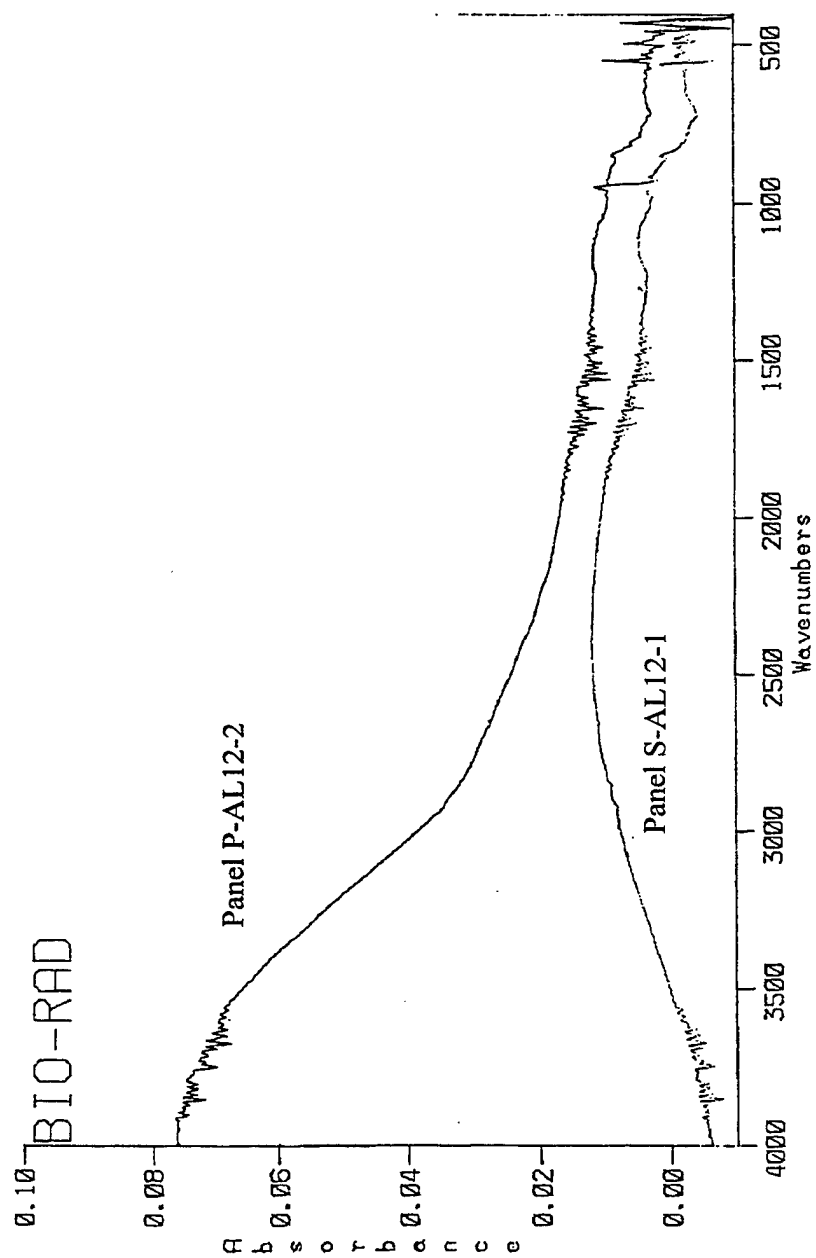
Figure 17. Typical FTIR spectra of soil panels after degreasing with fresh Brulin 815 GD.

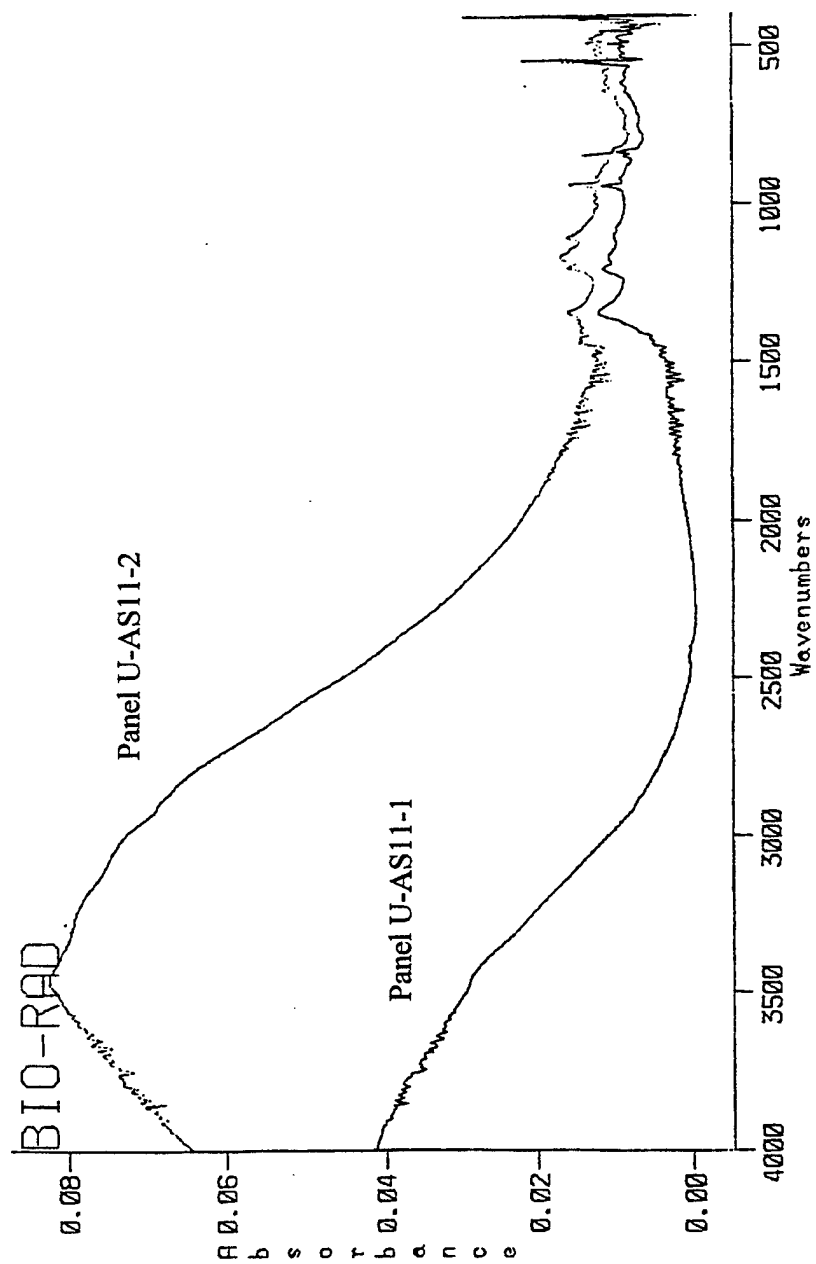
Figure 18. Typical FTIR spectra of soiled panels after degreasing with used Brulin 815 GD.

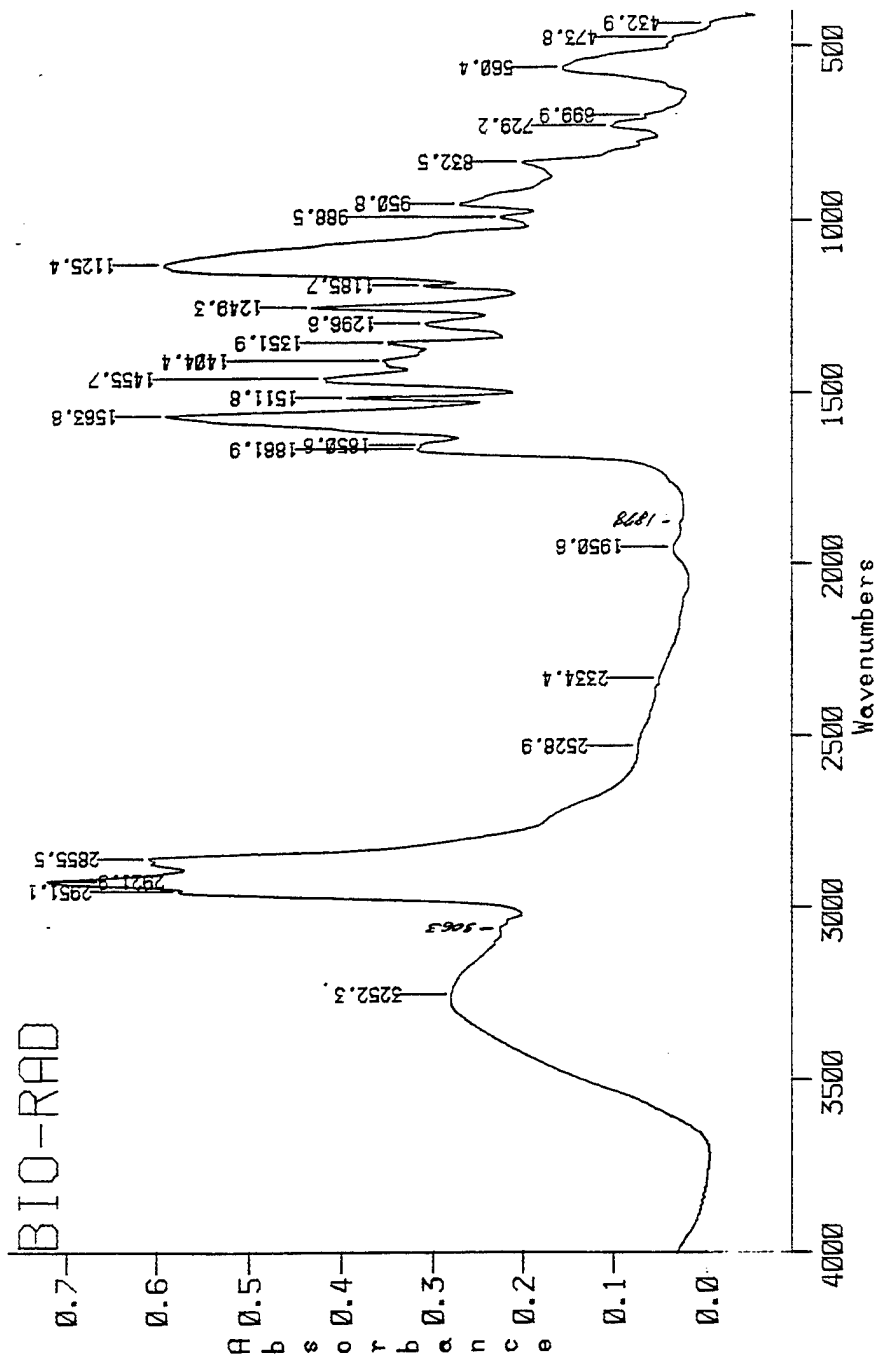
Figure 19. FTIR spectrum of Brulin 815 GD.

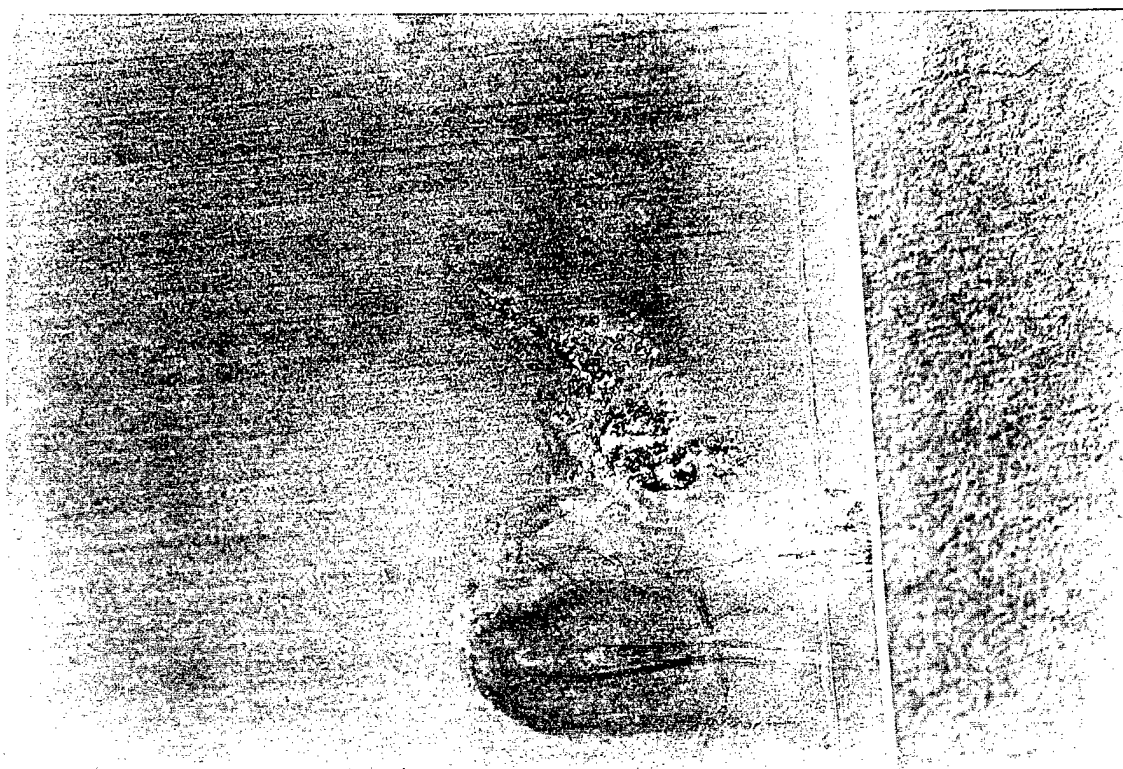
(a) Top side of panel.

(b) Bottom side of panel.

Figure 20. Stress corrosion cracks around ID stamp of conversion-coated panels exposed to 4 weeks of salt fog.

After 4 weeks of exposure, all panels, including the conversion-coated panels, exhibited no more than a single pit which could not be tied to original defects. However, the conversion-coated panels did experience corrosion at the panel identification stamps which was not observed on the anodized panels. The typical appearance of these stress-corrosion cracks is shown in Figure 20. These cracks were observed on all the conversion-coated panels and no difference could be established between panels subjected to the different cleaning processes.

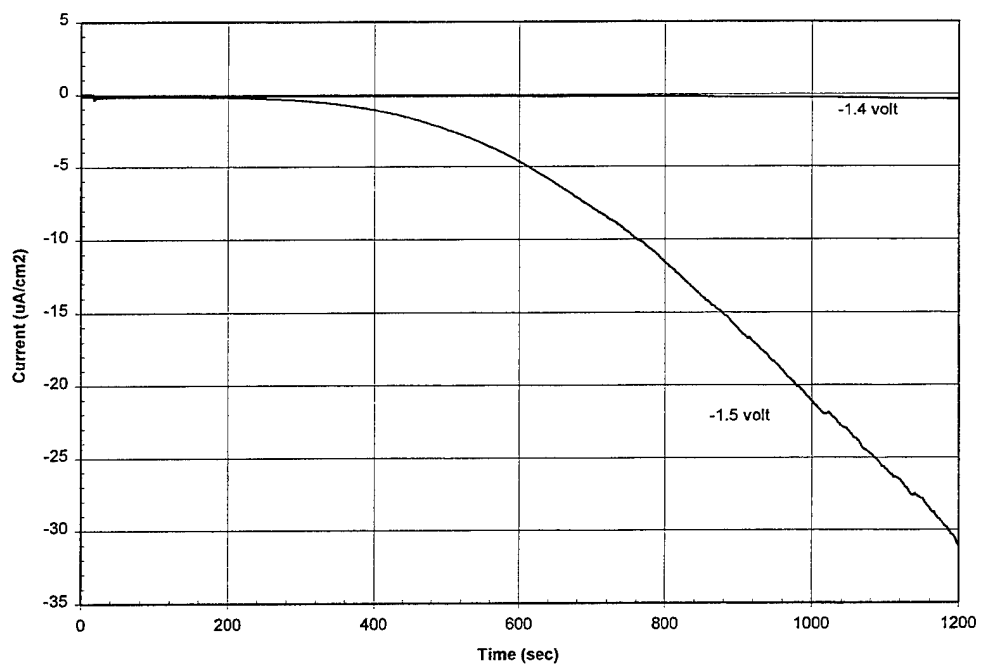
Figure 21. Cathodic breakdown behavior of vapor-degreased panel VS8.

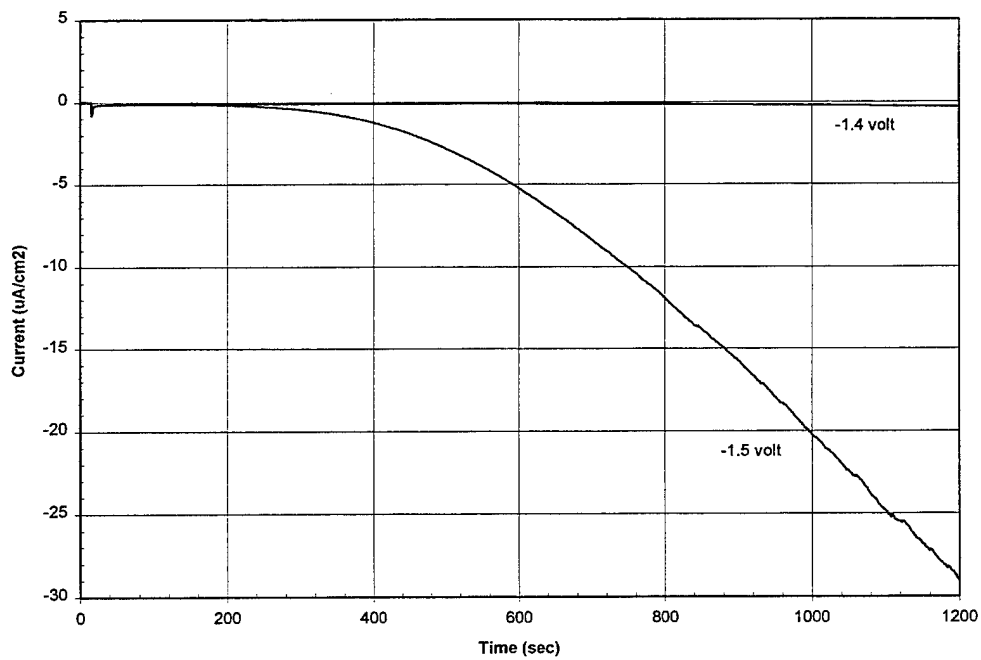
Figure 22. Cathodic breakdown behavior of vapor-degreased panel VS9.

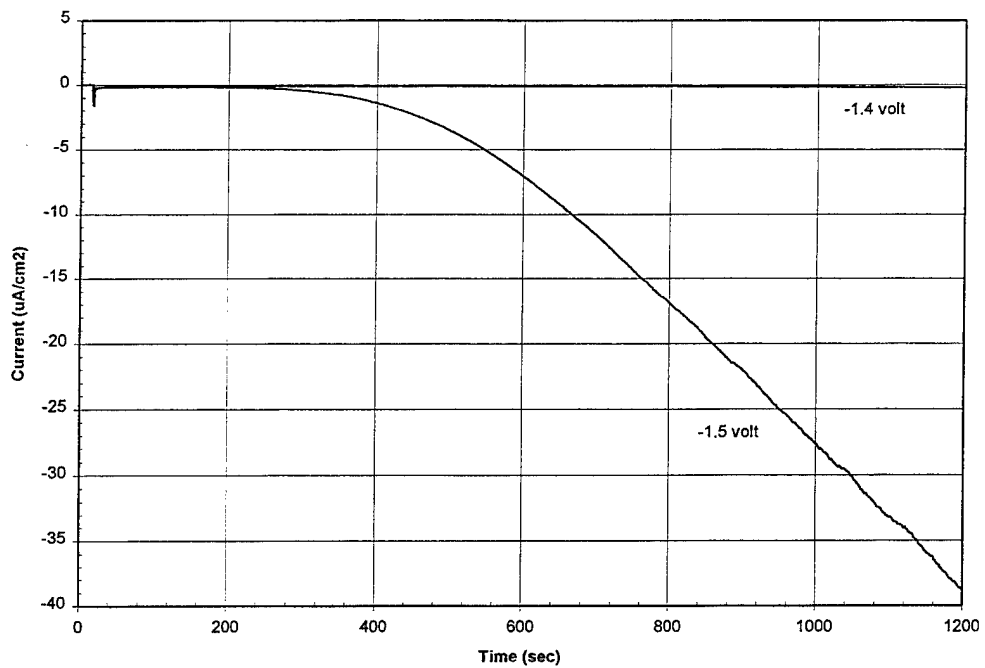
Figure 23. Cathodic breakdown behavior of panel AL9 cleaned in fresh Brulin 815 GD.

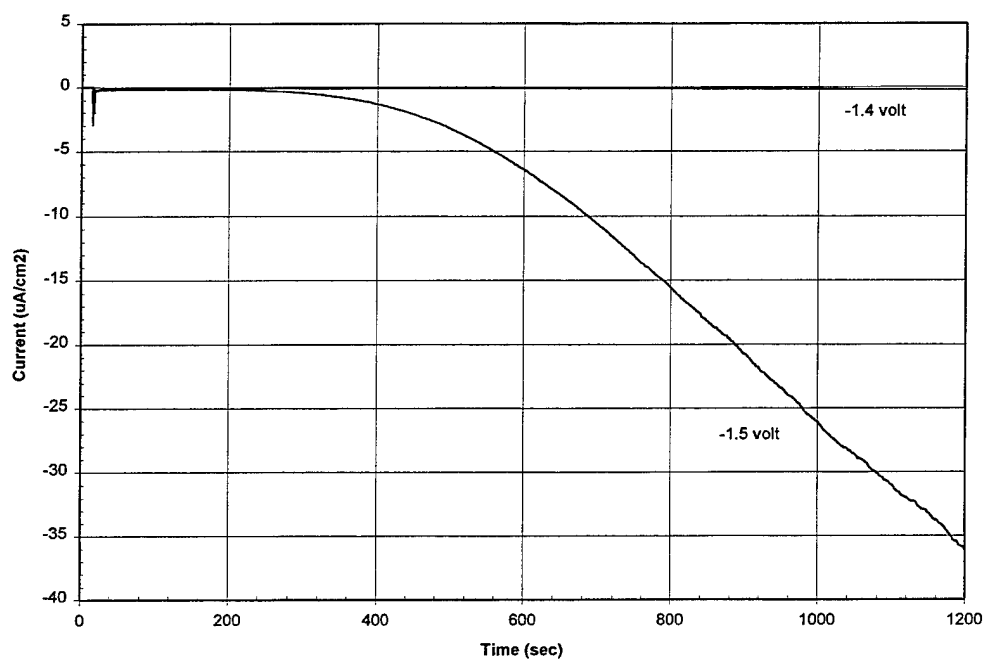
Figure 24. Cathodic breakdown behavior of panel AL10 cleaned in fresh Brulin 815 GD.

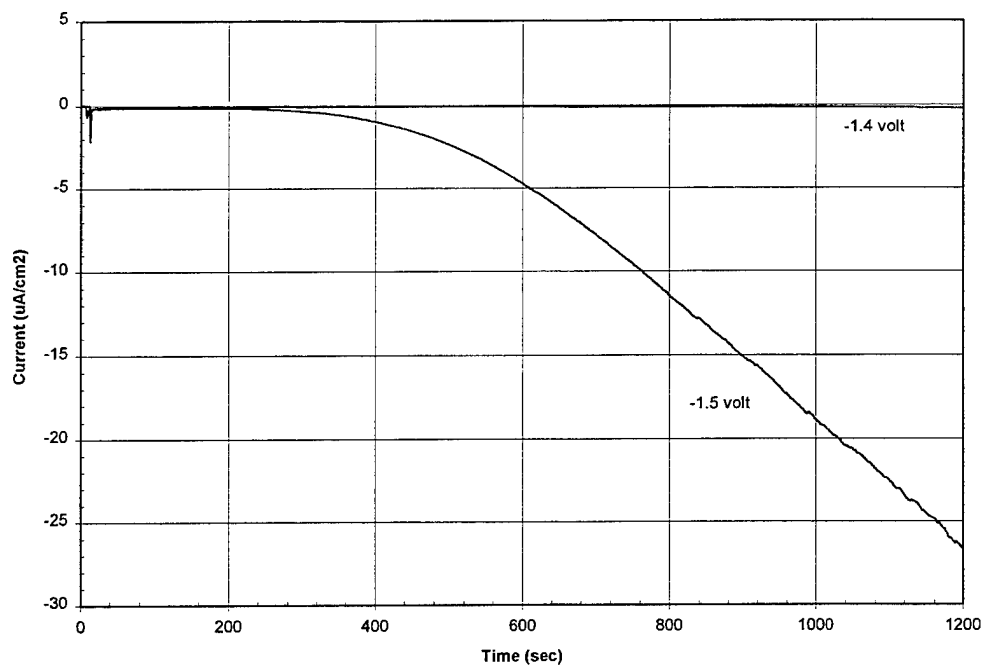
Figure 25. Cathodic breakdown behavior of panel AS9 cleaned in used Brulin 815 GD.

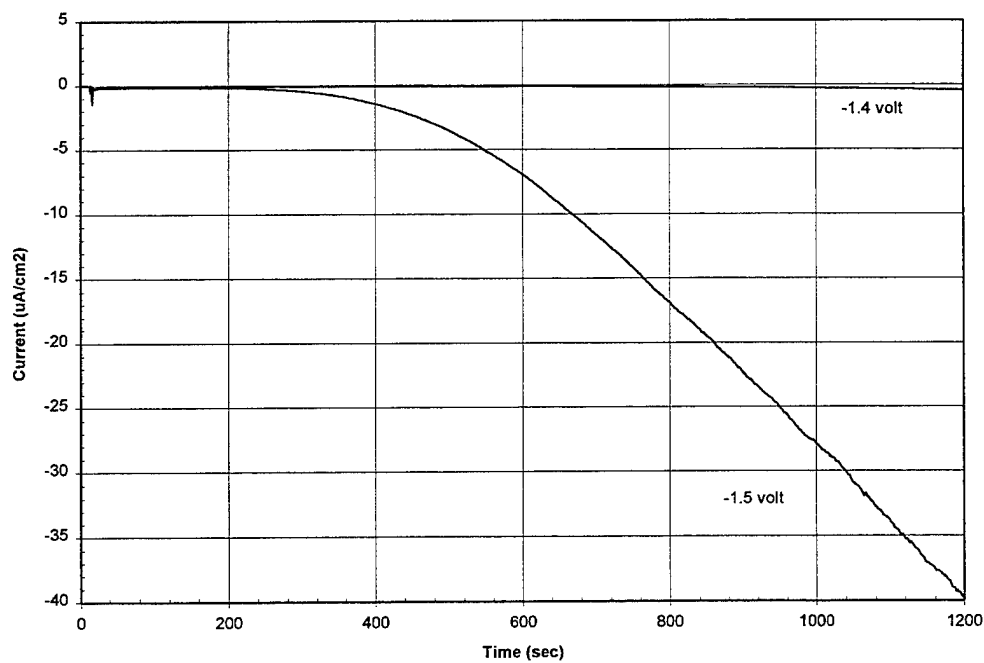
Figure 26. Cathodic breakdown behavior of panel AS10 cleaned in used Brulin 815 GD.

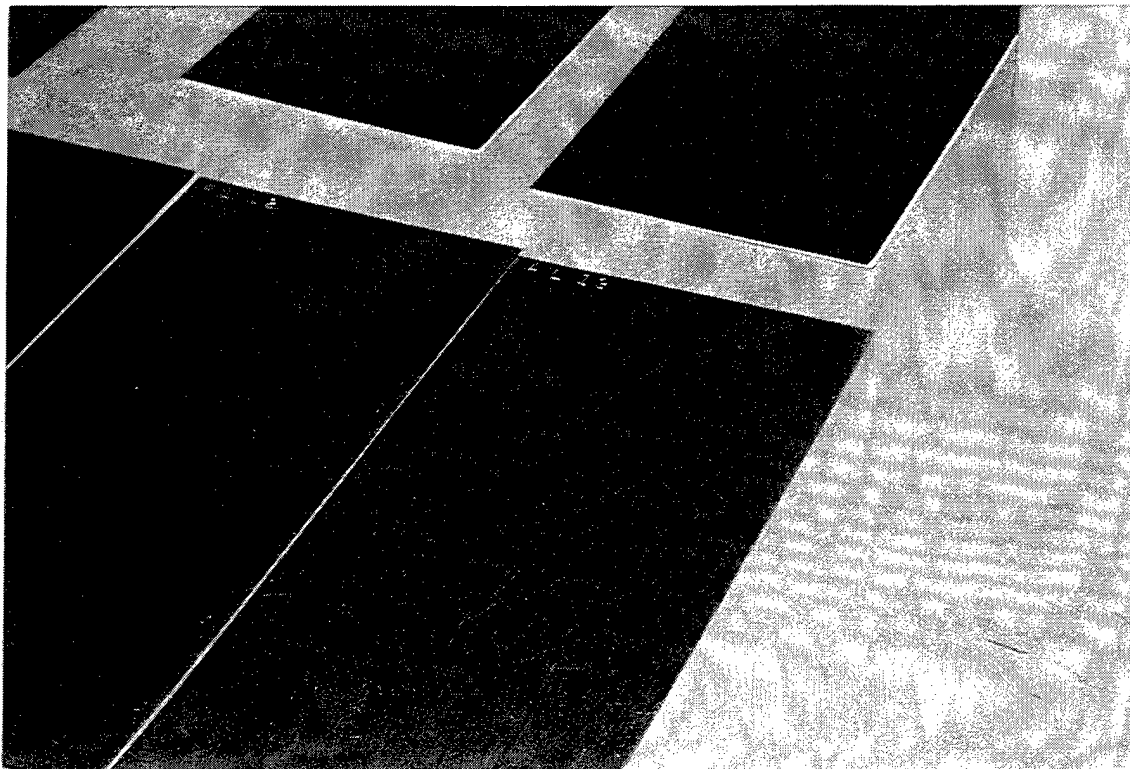
Figure A-1. ID markings are stamped on the panels.

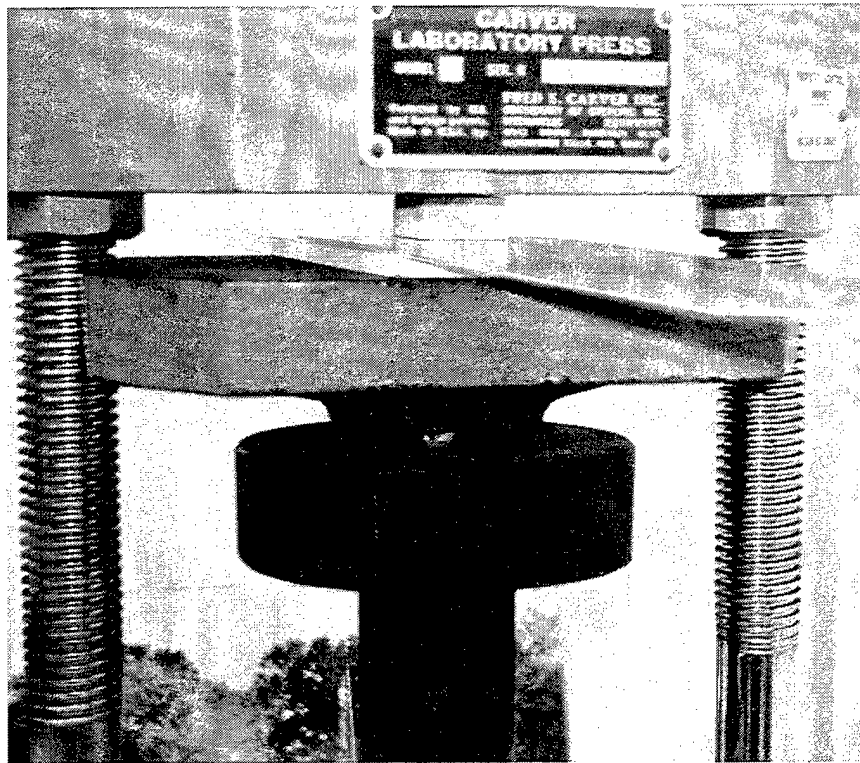
Figure A-2. Forming stresses simulated by placing panels in a laboratory press.

9. On the contaminated side of every contaminated panel, at the bottom and center of the panel (location of ID markings is considered the top), forming stresses were simulated by placing them in a small press and applying a 2,000-pound force over a 1-inch-square area for at least 5 seconds as shown on Figure A-2.
